REPAIR, EVALUATION, MAINTENANCE, AND
REHABILITATION RESEARCH PROGRAM

TECHNICAL REPORT REMR-CO-1

STABILITY OF RUBBLE-MOUND BREAKWATER AND JETTY TOES; SURVEY OF FIELD EXPERIENCE

Dennis G. Markle

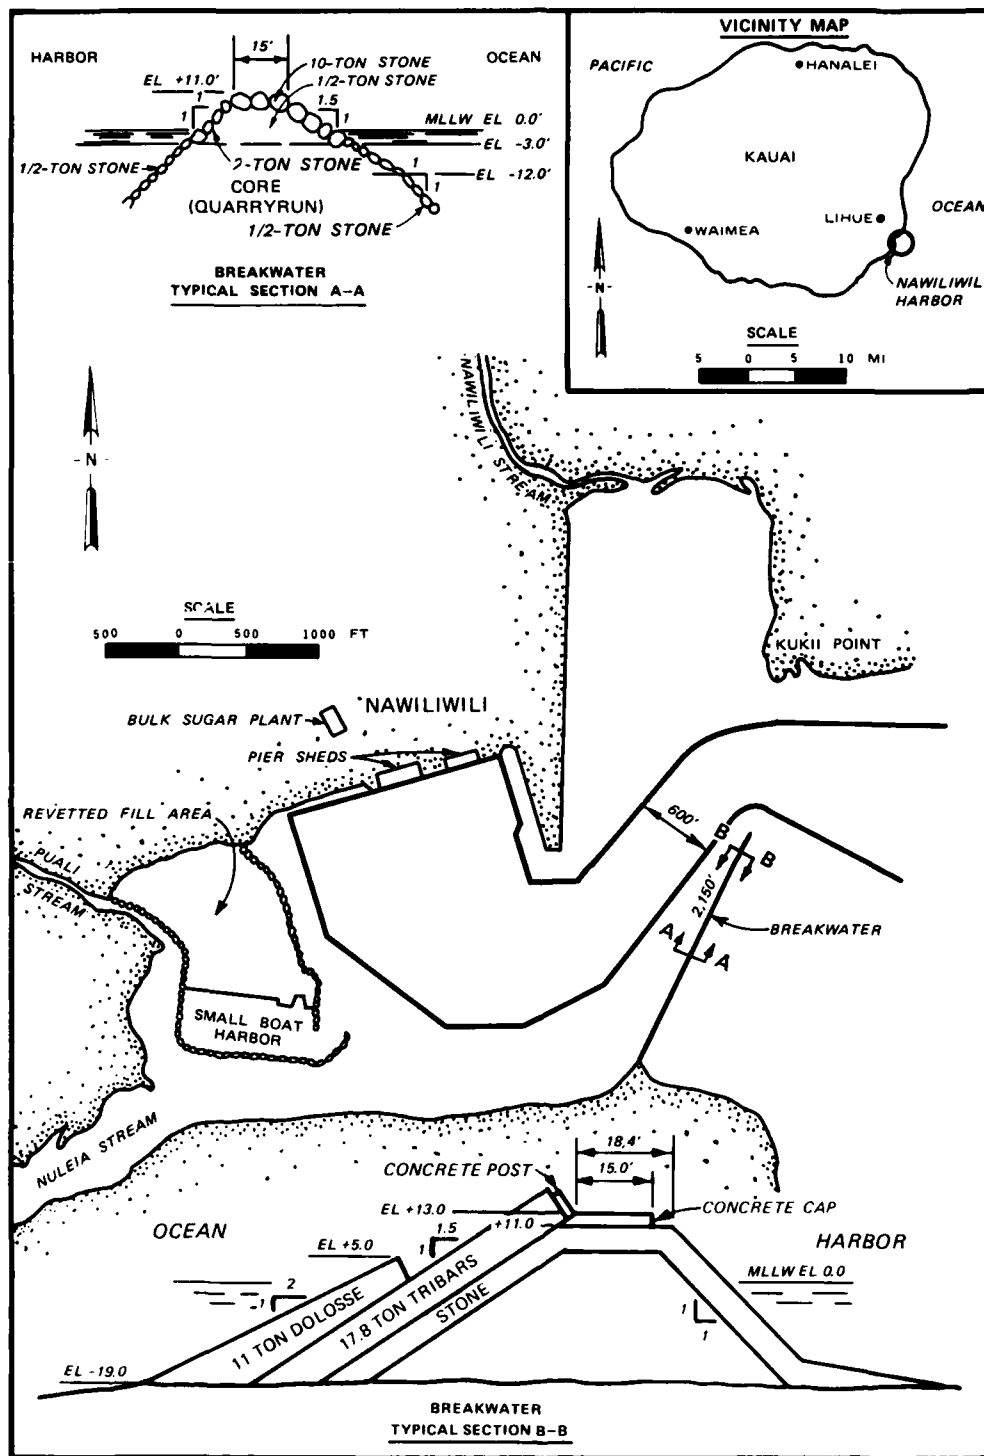
Figure 1. Nawiliwili Harbor Breakwater, Kauai, Hawaii

10. The Honolulu District of POD has three breakwaters which have problems and/or design questions that are related to toe stability. Two of the structures, Nawiliwili and Hilo, had a related problem. The head and adjacent 500 ft* of breakwater trunk at Nawiliwili Harbor, Kauai, Hawaii (Figure 1), were rehabilitated in 1959 using 17.8-ton tribars. Model

tests*, conducted at WES in 1958, revealed that two layers of randomly placed tribars on the head and one layer of uniformly placed tribars on the trunk were the best methods of rehabilitating the storm damaged structure. A survey in 1975 revealed extensive tribar breakage, and later it was found that the toe buttressing stone recommended for placement at the toe of the one layer of uniformly placed tribars had not been incorporated into the construction specifications. It was surmised that in the absence of these buttressing stones the tribar toe slid on the hard bottom which resulted in an en masse slippage and breakage of several tribars. This area was rehabilitated with two layers of randomly placed 11-ton dolosse on slope and through the use of special placement of the toe dolosse. This latter work was also model-tested at WES.**

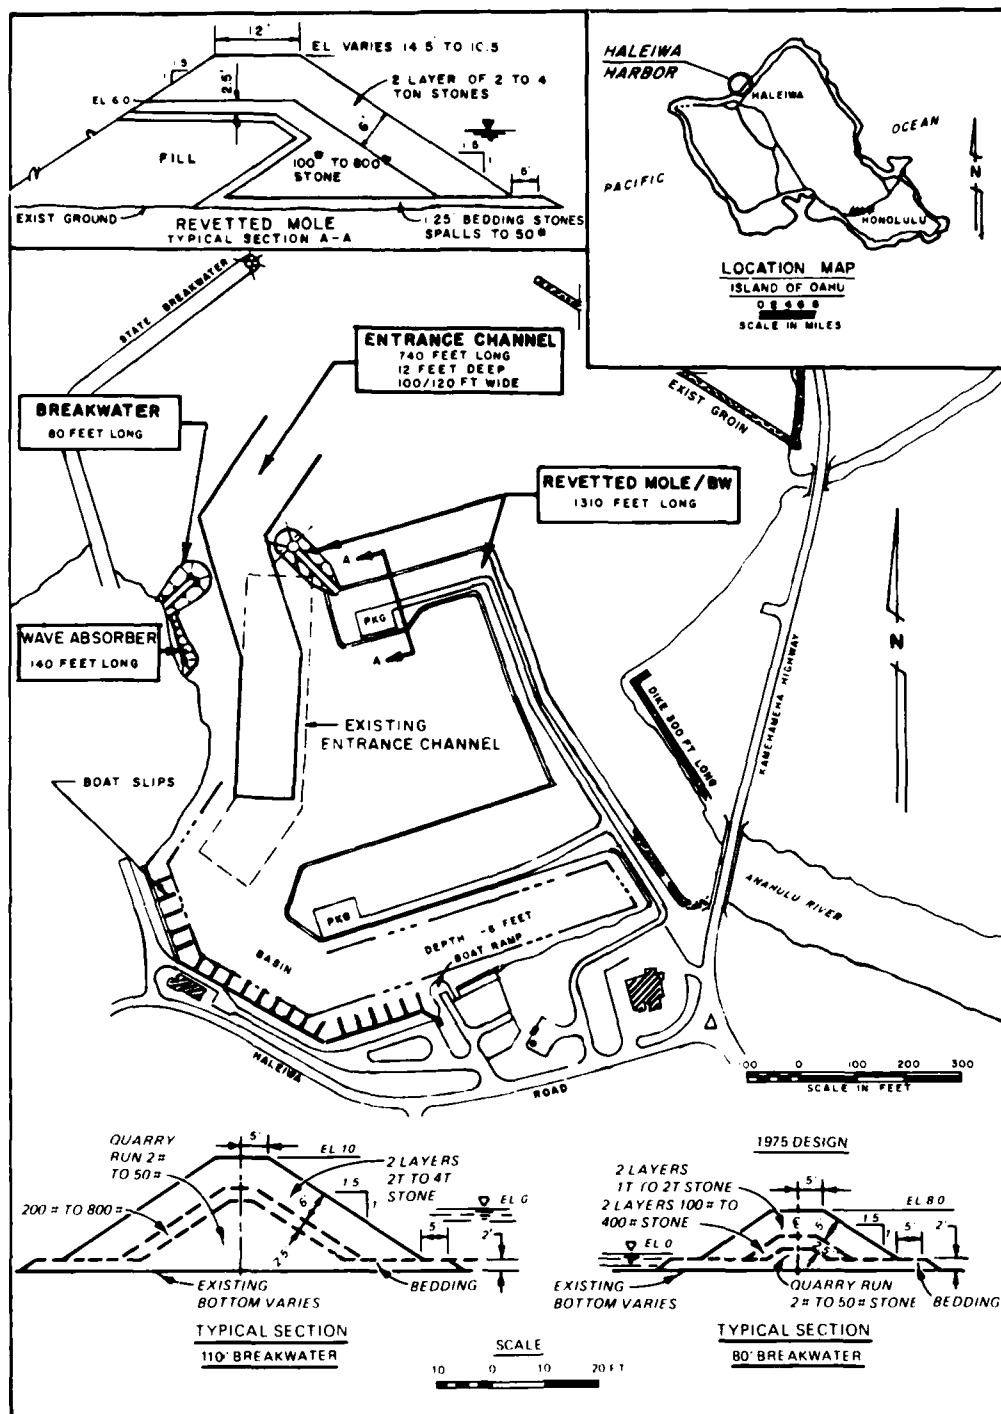
Figure 3. Haleiwa Harbor Breakwaters, Oahu, Hawaii

12. Haleiwa Harbor, located on the north side of the Island of Oahu, Hawaii (Figure 3), was modified in 1975 by the addition of a revetted mole and two stub breakwaters. Subsequent to this time, repairs were required on the 80-ft breakwater due to a slippage failure of the primary armor stone. Close inspection of the structure revealed that the bedding and berm had been

omitted from the construction. Localized scour had undermined the armor stone toe and resulted in the slippage failure. The structure was repaired by excavating around the perimeter of the structure down to firm bottom and overlaying the structure head with an additional layer of 1- to 2- ton armor stone which extended down to the toe. This repair was feasible due to the shallow depth of the sand in the area of the west breakwater. No stability problems have been observed since the repair was completed.

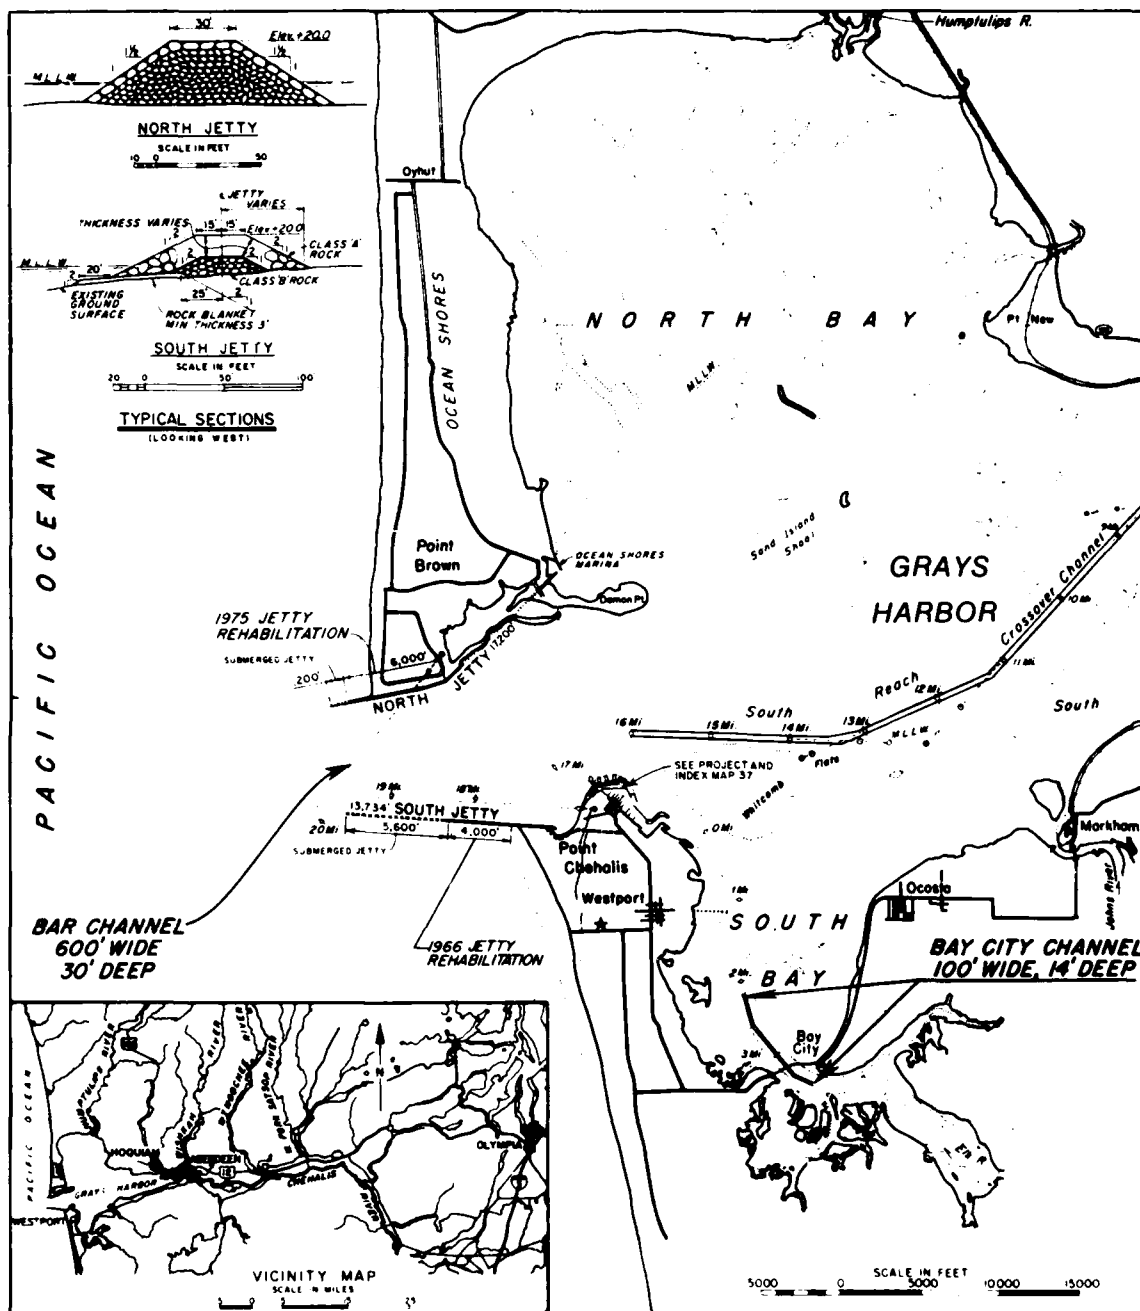
Figure 4. Grays Harbor Jetties, Washington

13. The south jetty at the entrance to Grays Harbor, Washington (Figure 4), has sustained severe scour on the channel side toe. The outer 5,600 ft of the jetty are presently below mean lower low water (mllw). It is not known if the toe scour is the cause, or a portion of the cause, of the present deteriorated condition of the jetty. Presently, no repair work is planned for the Grays Harbor Jetties.

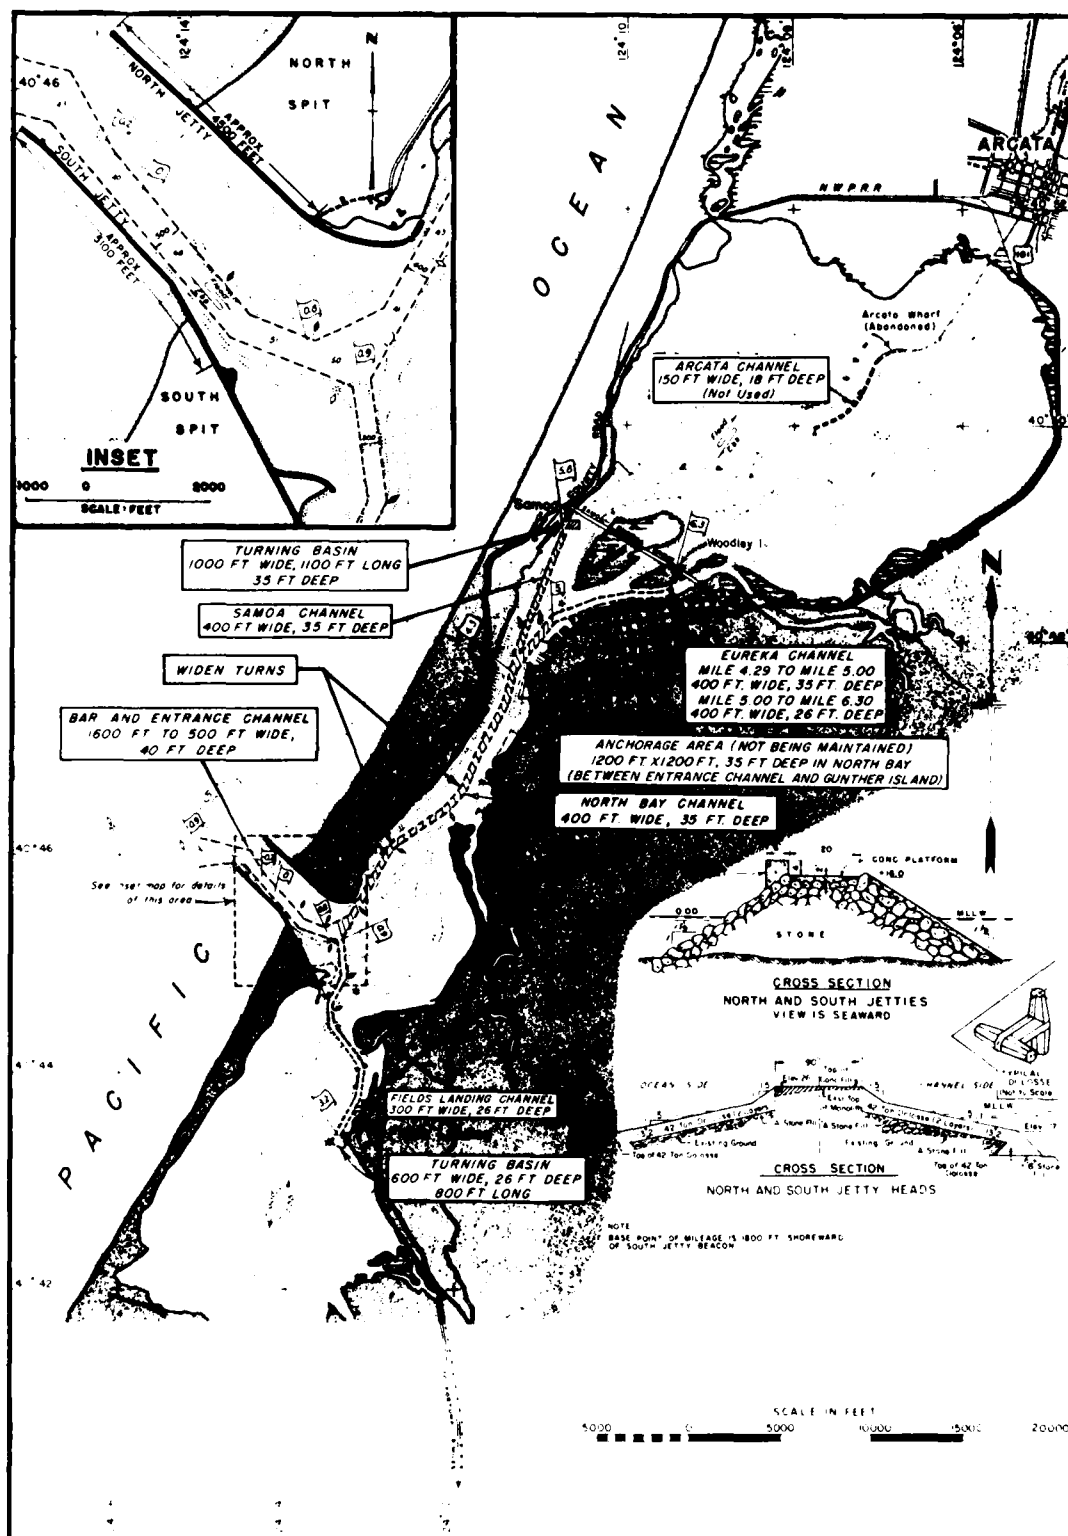
Figure 15. Humboldt Bay Jetties, California

16. The San Francisco District sited the jetties at Humboldt Bay (Figure 15) as being the only area showing obvious toe stability problems. The channel side of the north jetty and exposed side of the south jetty have shown obvious signs of scour and undermining which resulted in instability and slippage of the dolos toe. Condition surveys of the area have revealed the depths of the scour holes appear to have a seasonal fluctuation. An armor stone berm, extending from 70 to 100 ft out from the existing dolos toes, was included in the jetty repair work conducted in 1985. The multilayered berm consists of a 3- to 6-ton primary armor stone overlying two graded filter layers (Figures 16 and 17).

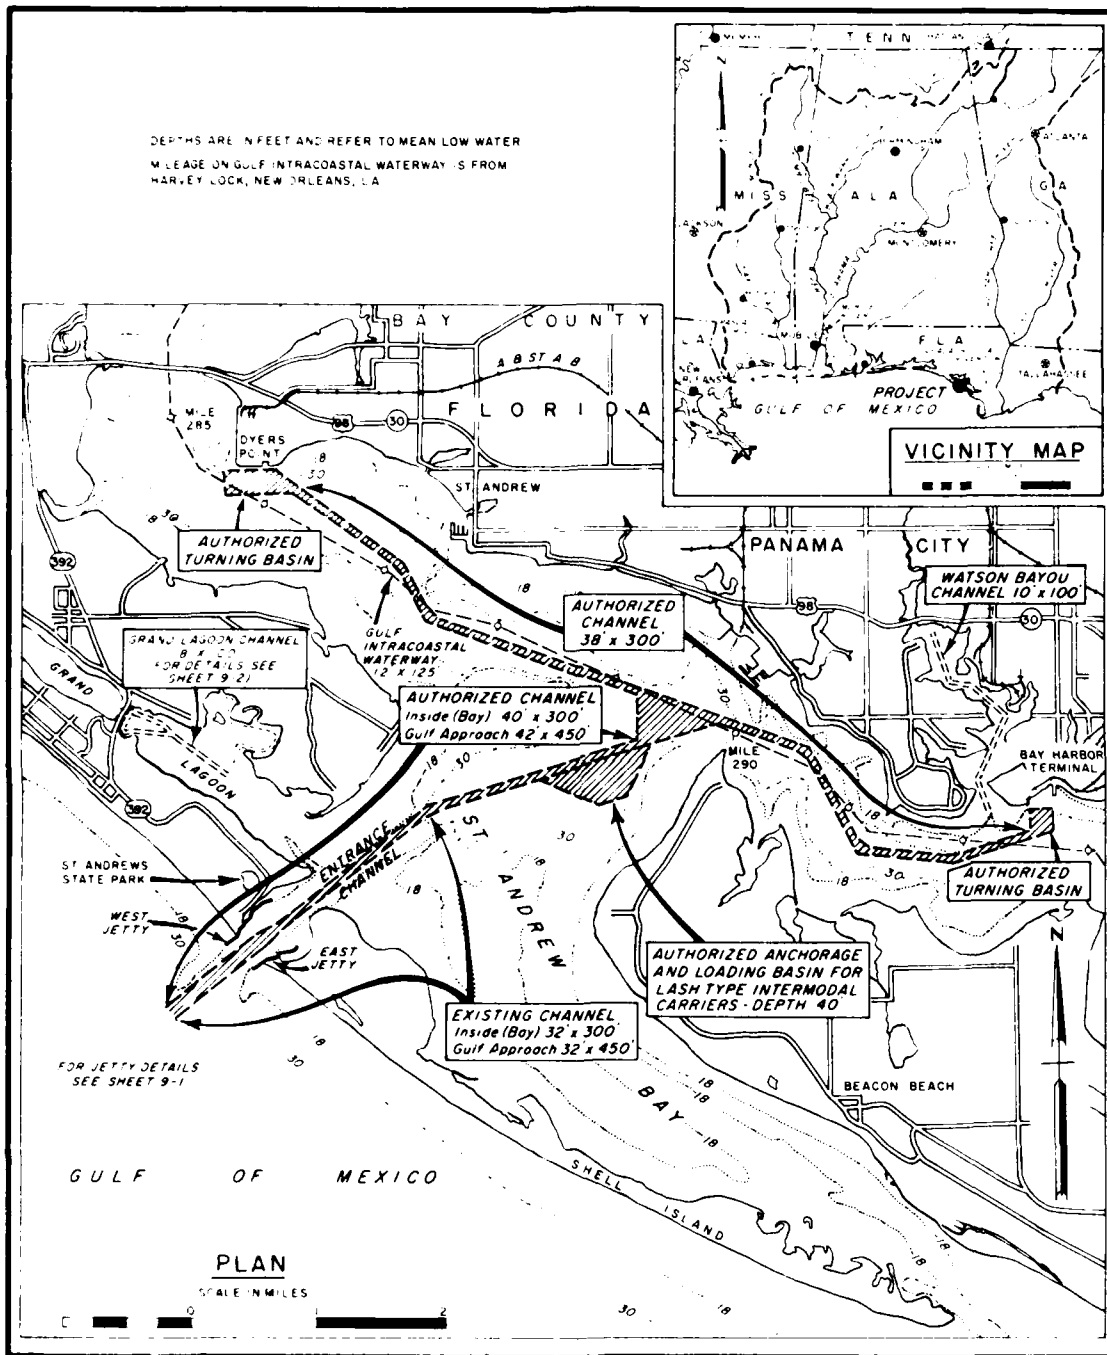
Figure 21. Panama City Harbor Jetties, Florida

20. During the period 1937 to 1938 attempts were made to alleviate toe scour problems on the Panama City Harbor Jetties (Figures 21 and 22) by encasing the jetties with asphaltic concrete. Asphaltic concrete mats (2 in. thick) were anchored on the channel side of the jetties and extended over the jetties to a point 24 ft seaward of the existing jetty toe. A hot asphaltic concrete was poured over the matting in an effort to bond the mats together

as well as stabilize them to the existing armor stone structure. This design proved to be unsuccessful. Scour initiated at the toes of the mats and, as the mats subsided into the scour holes, they pulled the mats and armor stone off the upper slope which resulted in general deterioration of the jetties. Subsequent repairs were carried out by placing a toe berm of 100- to 200-lb stone and, where needed, overlaying the old structure with additional armor stone.

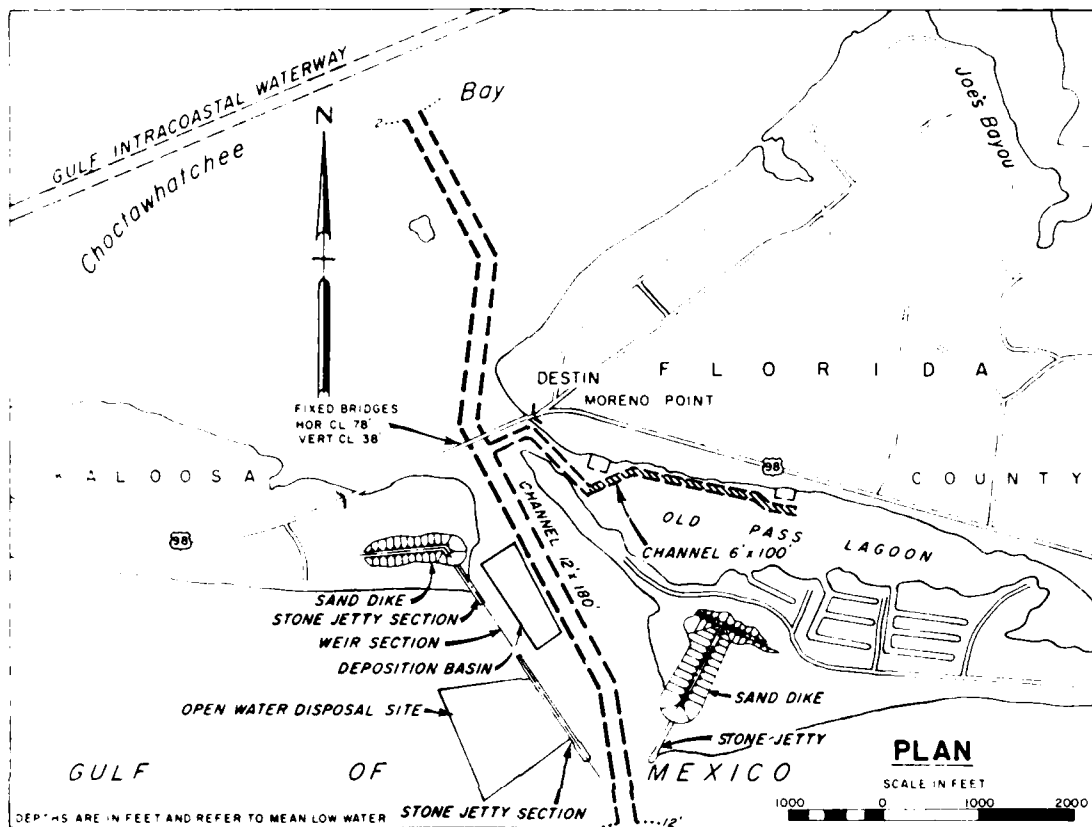
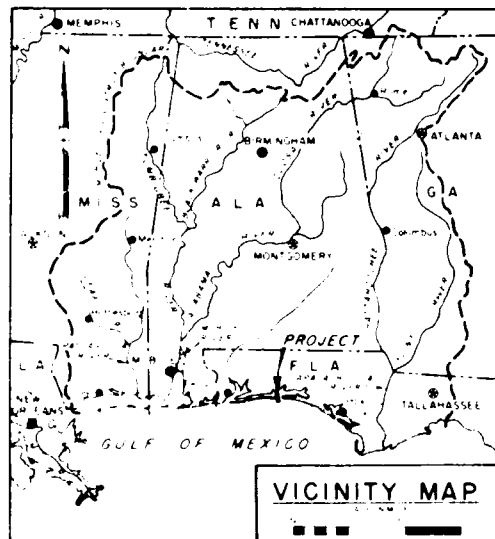
Figure 23. East Pass Channel Jetties, Florida

21. Toe scour also has been noted as a problem with the jetties at East Pass Channel and St. George Island, Florida, and Perdido Pass Channel, Alabama (Figures 23-25, respectively). Scour on the channel side of the east jetty at East Pass is so severe that it is thought that portions of the jetty may slide into the channel at any time. In the past, this type of slippage failure has caused severe damage to the west jetty at Panama City.

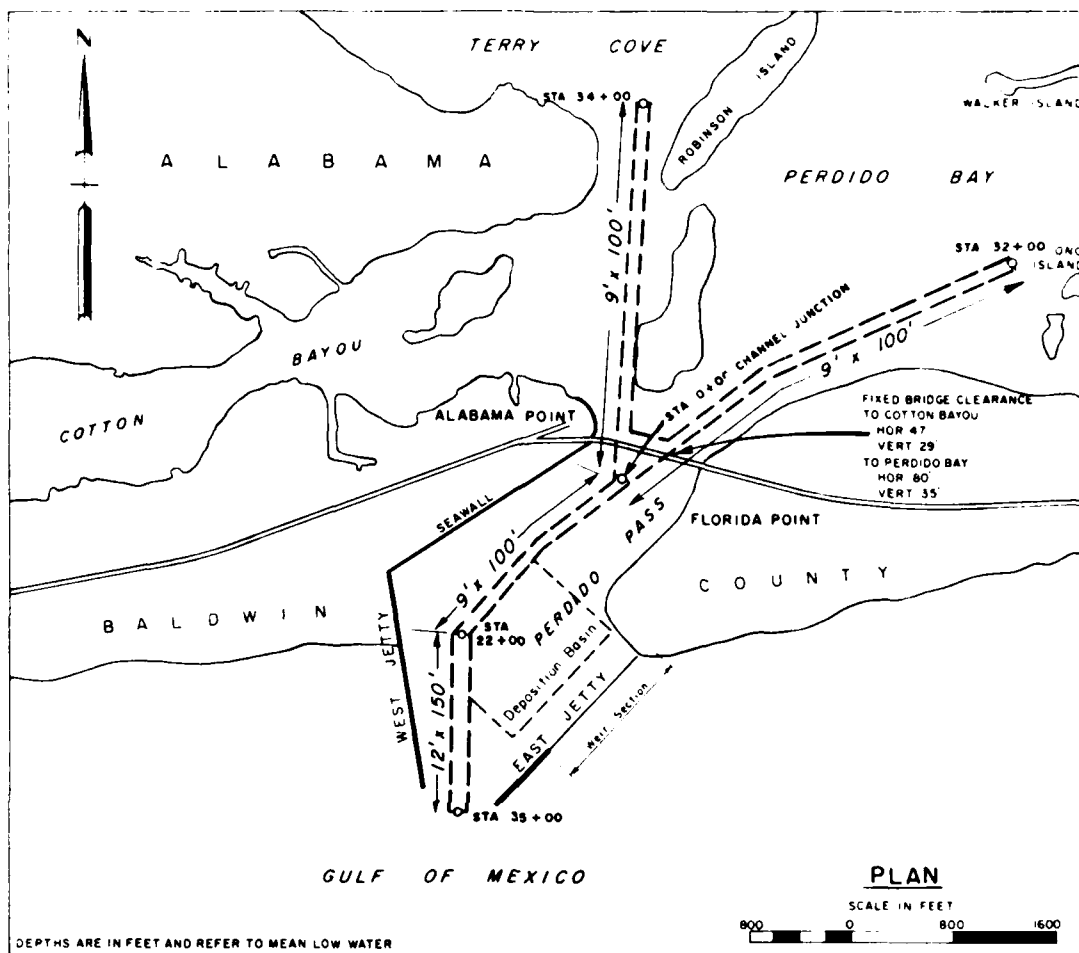
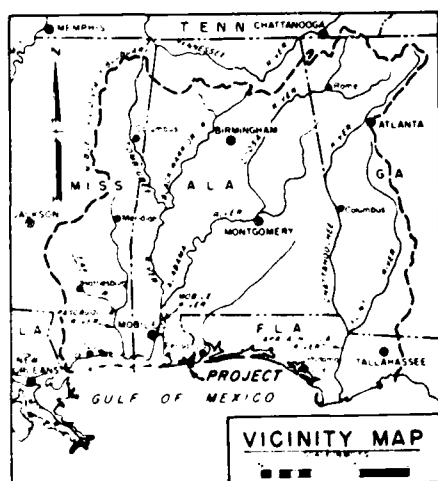
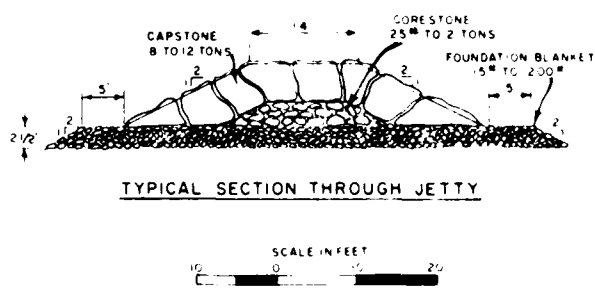
Figure 25. Perdido Pass Channel Jetties, Alabama

22. Jetties at St. George Island have suffered cover stone loss resulting from the undermining action of toe scour. The west jetty at Perdido Pass presently has significant amounts of toe scour on the channel side, and Hurricane Frederick produced significant amounts of toe scour on the east jetty. The overall condition of the Perdido Pass jetties was said to be good; therefore, it is assumed that the toe scour has not caused any obvious damage above the waterline.

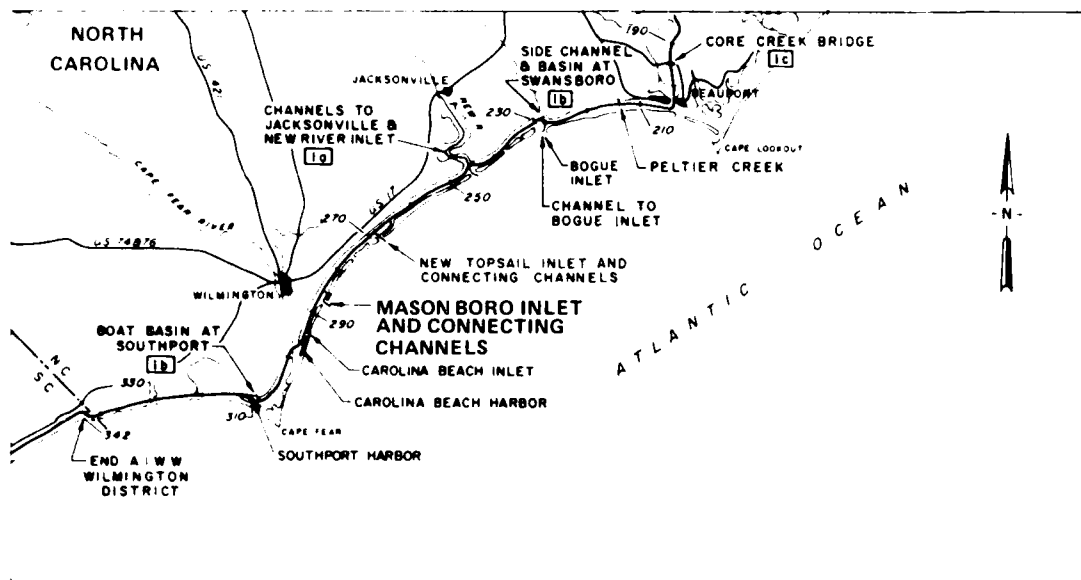
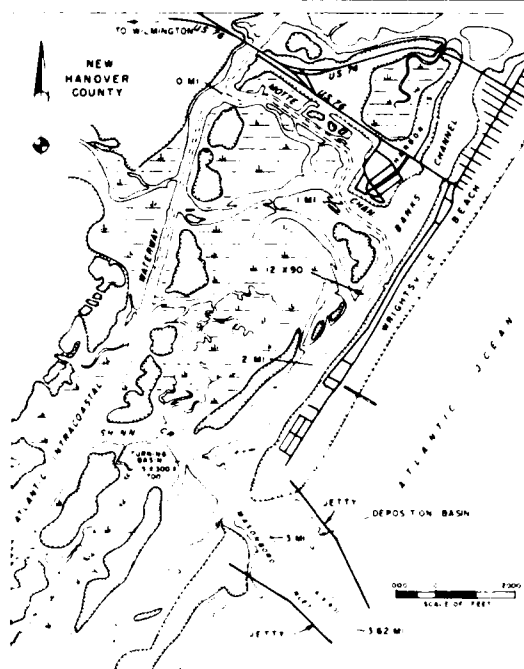
Figure 26. Masonboro Inlet Jetties, North Carolina

23. The 3,650-ft-long rubble-mound north jetty located at Masonboro Inlet, North Carolina (Figure 26), was constructed between August 1965 and June 1966. The north jetty required extensive repair on the channel-side toe of the outer rubble-mound structure in 1969 and to the channel-side toe of the inner weir section in 1973. This was prior to construction of the south jetty (14- to 22-ton armor stone) in 1980. It was thought that ebb and flood flows had caused the channel to move adjacent to the north jetty, creating the scour problem. In both repairs, a 2- to 3-layer protection of bedding material and riprap (25 to 2,000 lb) was used. This toe protection butted against the existing armor stone toe or sheet-pile weir. The berm width varied from 30 to 50 ft. It is thought that this work had limited success because the jetty has not totally deteriorated, but it is presently in need of repair work in several areas. Presently it is unknown whether the deteriorated appearance of the north jetty results from a toe scour problem or from the possibility

that the original 7- to 12-ton armor stone may have been an inadequate design for the incident wave environment.

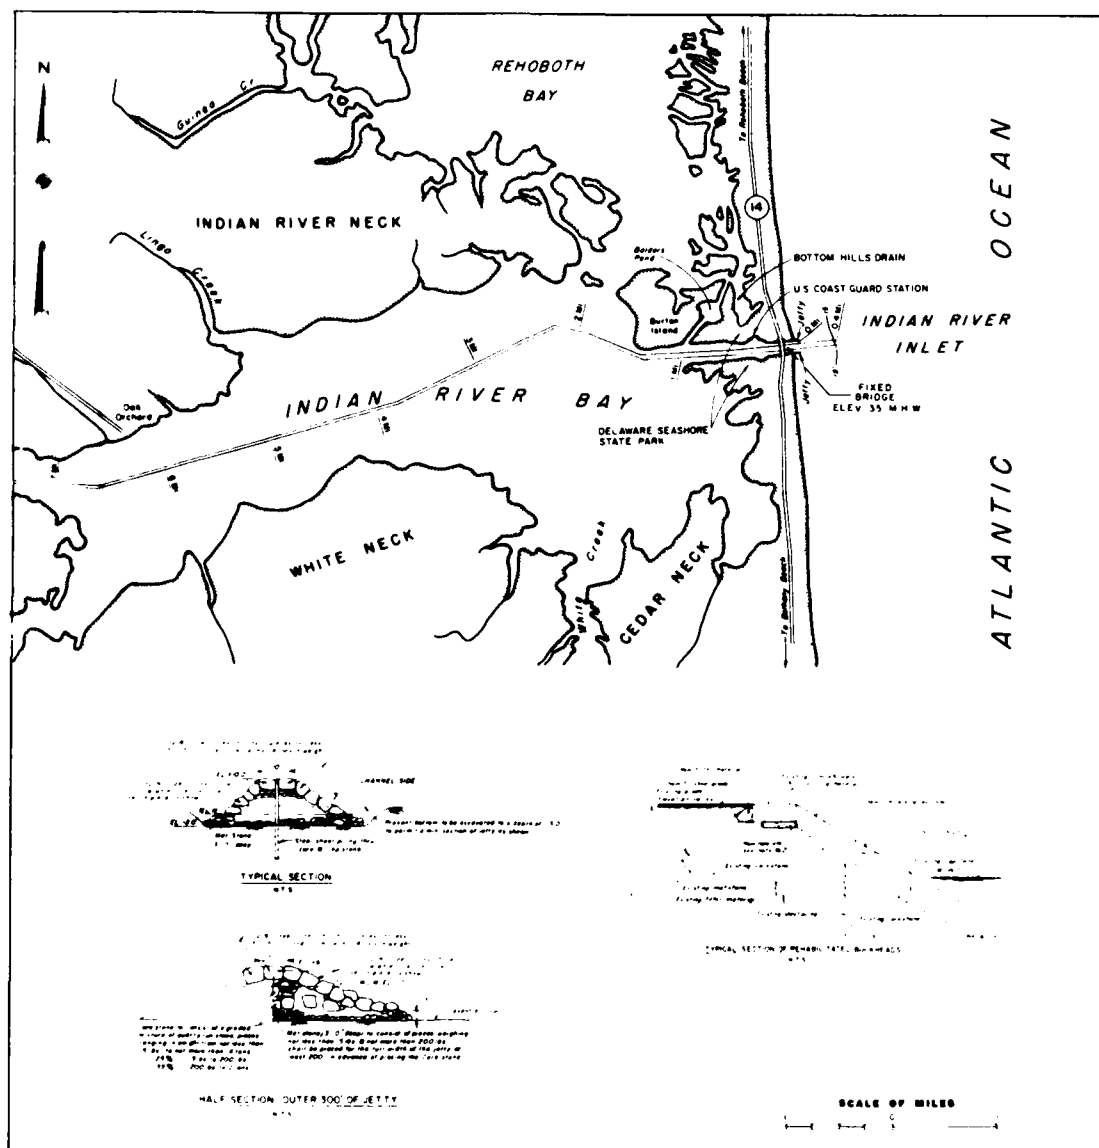
Figure 29. Indian River Inlet Jetties, Delaware

27. The rubble-mound and sheet-pile composite jetties at Indian River Inlet, Delaware, were completed in 1939 (Figure 29). The jetties required storm damage repairs in 1956 and 1957. At that time, the north jetty was extended inshore a distance of 320 ft. At present both jetties are 1,566 ft long. Both jetty heads have deteriorated significantly from a combination of toe scour, armor stone slippage and displacement, and overall subsidence. Because of the success of the Manasquan River Jetty repairs, dolosse are being considered for inclusion in the repair and rehabilitation designs for the structure slopes. No details on the proposed toe repair design are available.
